# ANNUAL REPORT FOR 2011

**UT to Middle Fork Creek Site C Mitigation Site  
Madison County  
TIP No. R-2518A**

Prepared By:  
Natural Environment Unit & Roadside Environmental Unit  
North Carolina Department of Transportation  
December 2011

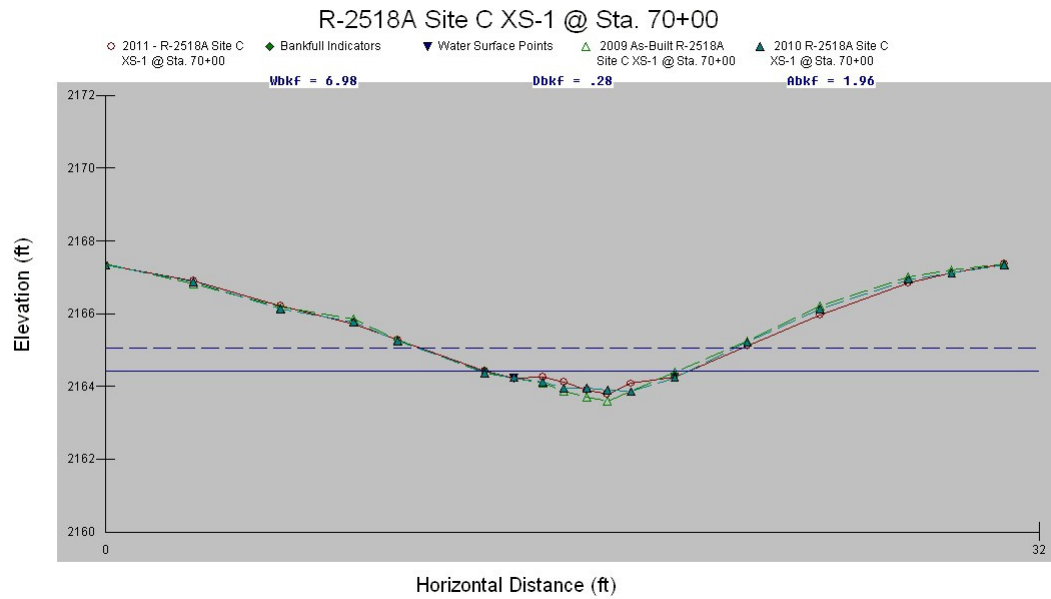
Site C: Cross-Section #1 (Riffle) Abbreviated Morphological Summary					
	2010	2011	2012	2013	2014
Bankfull Cross Sectional Area (ft <sup>2</sup> )	2.07	1.96			
Maximum Bankfull Depth (ft.)	0.52	0.63			
Width of the Floodprone Area (ft.)	10.01	11.05			
Bankfull Mean Depth (ft.)	0.3	0.28			
Width/Depth Ratio	22.87	24.93			
Entrenchment Ratio	1.46	1.58			
Bankfull Width (ft.)	6.86	6.98

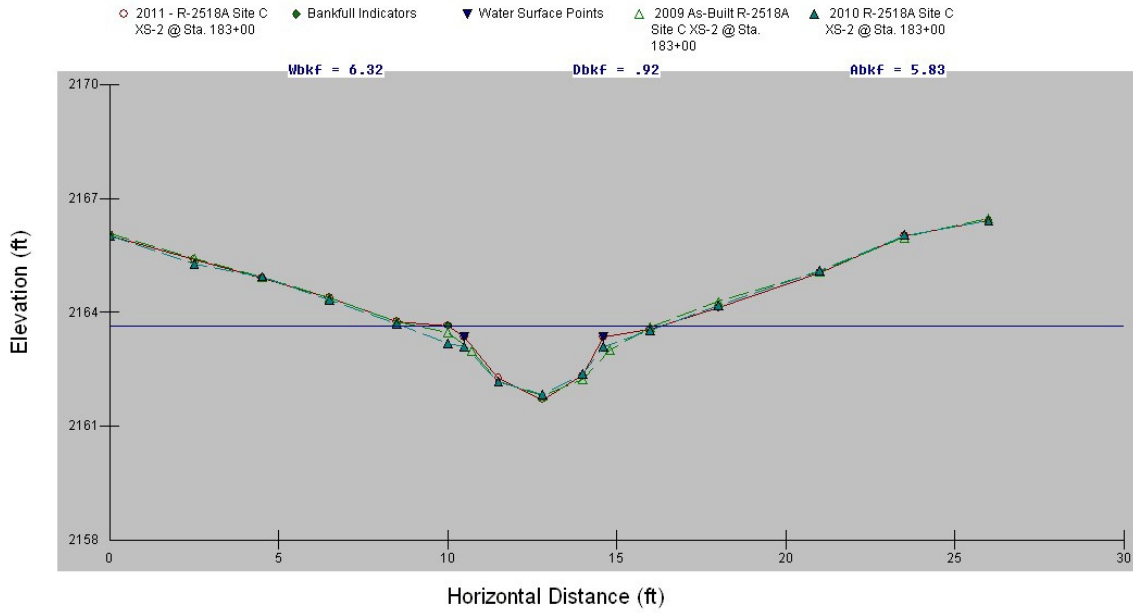
# R-2518A Site C XS-2 @ Sta. 183+00

Site C: Cross-Section #2 (Pool) Abbreviated Morphological Summary					
	2010	2011	2012	2013	2014
Bankfull Cross Sectional Area (ft <sup>2</sup> )	3.62	5.83			
Maximum Bankfull Depth (ft.)	1.34	1.95			
Bankfull Mean Depth (ft.)	0.75	0.92			
Bankfull Width (ft.)	4.84	6.32
